**ADDENDUM NO. 2  
TO  
CONTRACT DOCUMENTS  
FOR  
653 COOK AVENUE**

This document has been assembled to aid Contractors in preparing their bids for this Project. The present condition of the property is one of mid-construction. Assessment has been taken of the work completed and recommendations are made as to; acceptance of the Work, unfinished Work, rejection of the Work, and Work to be completed. Photographs have been included, in each specification section where appropriate, to provide additional clarification.

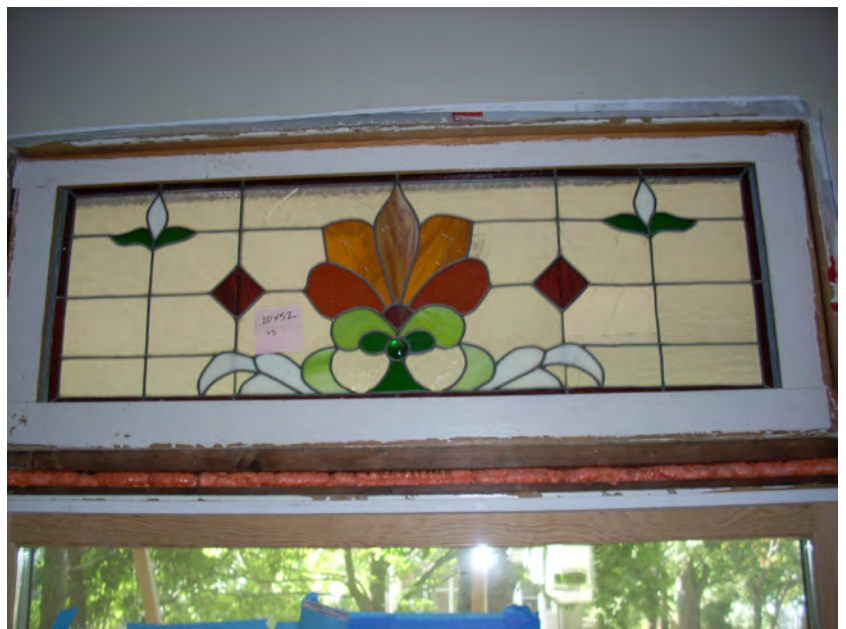
A. South Living Room stained glass window

Repair not completed

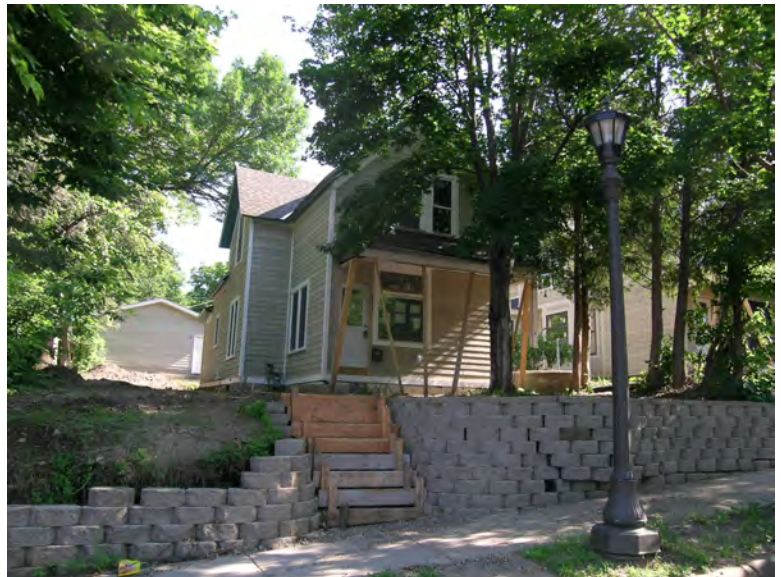
- A. Replace existing retaining wall in front yard at south property line - **partially installed**

**ADD:** Additional retaining wall a back patio

1. We recommend the stack block retaining walls on the property be rebuilt with the proper tie-back system per the manufacturer's recommendations.
2. Installation of front porch framing and foundations are incomplete.

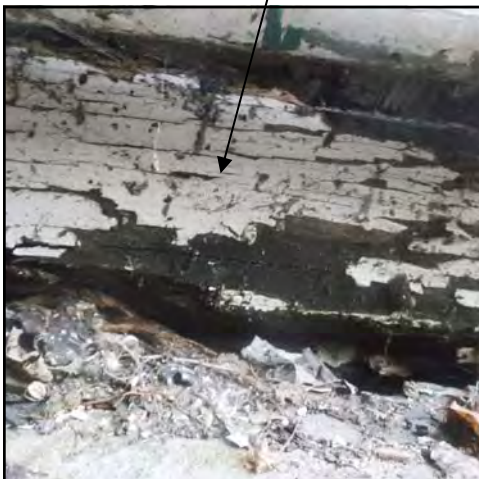
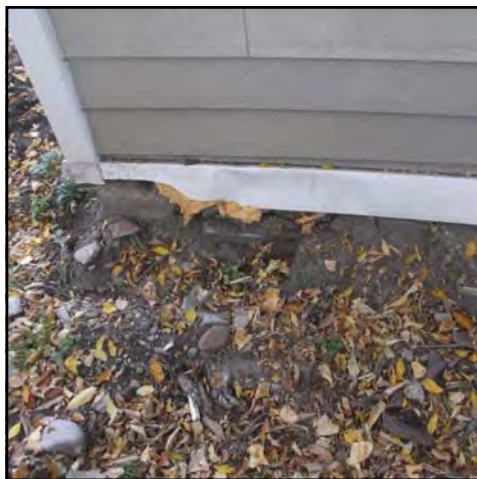
These images of the east side of the house towards the back show that there is some evidence of rotting wood that should be repaired. The bottom right image is of the back of the house. The soil should be removed and the foundation should be inspected for rot.
